Eradication and Surveillance of *Caulerpa taxifolia* within Huntington Harbour, Huntington Beach, California Status Report

May 2006

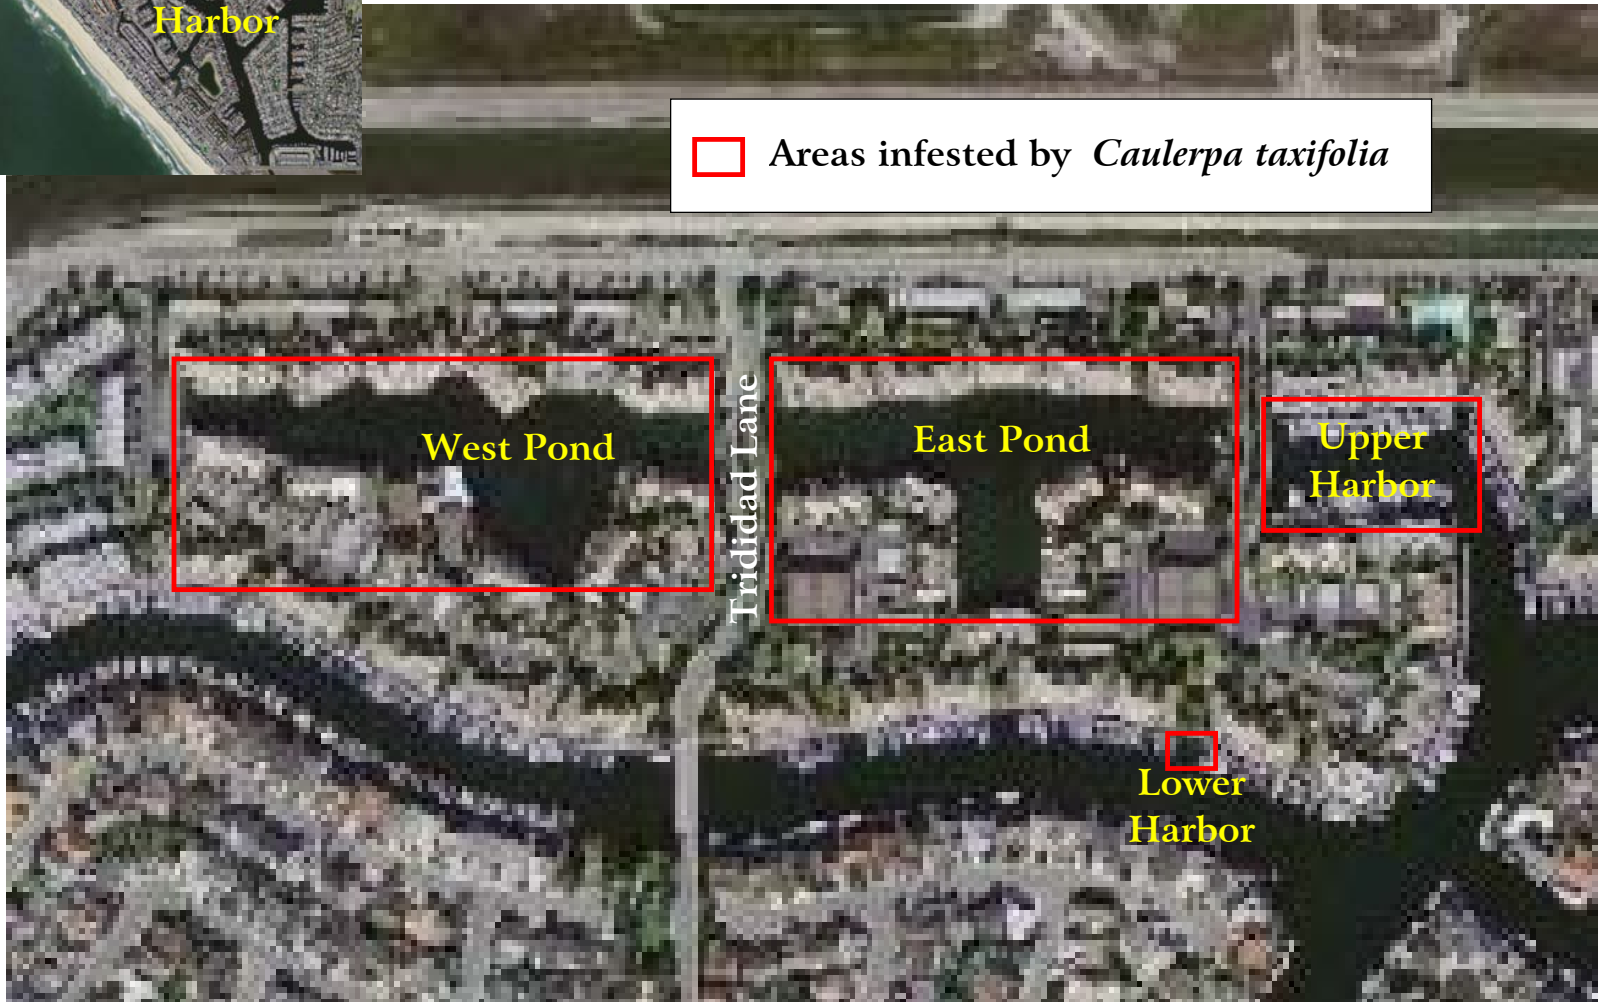
Figure
1

The Huntington Harbour *C. taxifolia* infestations were discovered in the northern portion of the harbor, primarily in the water bodies known as SeaGate Lagoons. The “lagoons” consist of two man-made ponds located on Trinidad Lane in the City of Huntington Beach (Figure 1). The ponds contain harbor water, but are non-tidal. Water level is maintained by pumps that fill the east pond with water from the harbor, which drains into the west pond, and then back out into Huntington Harbour. The ponds are enclosed on all sides by concrete bulkheads, with residential condominium patios forming the “banks” of the ponds. The ponds range from three to six feet

Caulerpa taxifolia infestation areas in Huntington Harbour - 2000
Huntington Beach, CA

In addition, *C. taxifolia* was discovered growing at two locations where outflow pipes drain the east pond back into the harbor. These sites are referred to as the north and south harbor sites (Figure 1). These areas reach a maximum depth of approximately -17 ft Mean Lower Low Water (MLLW).

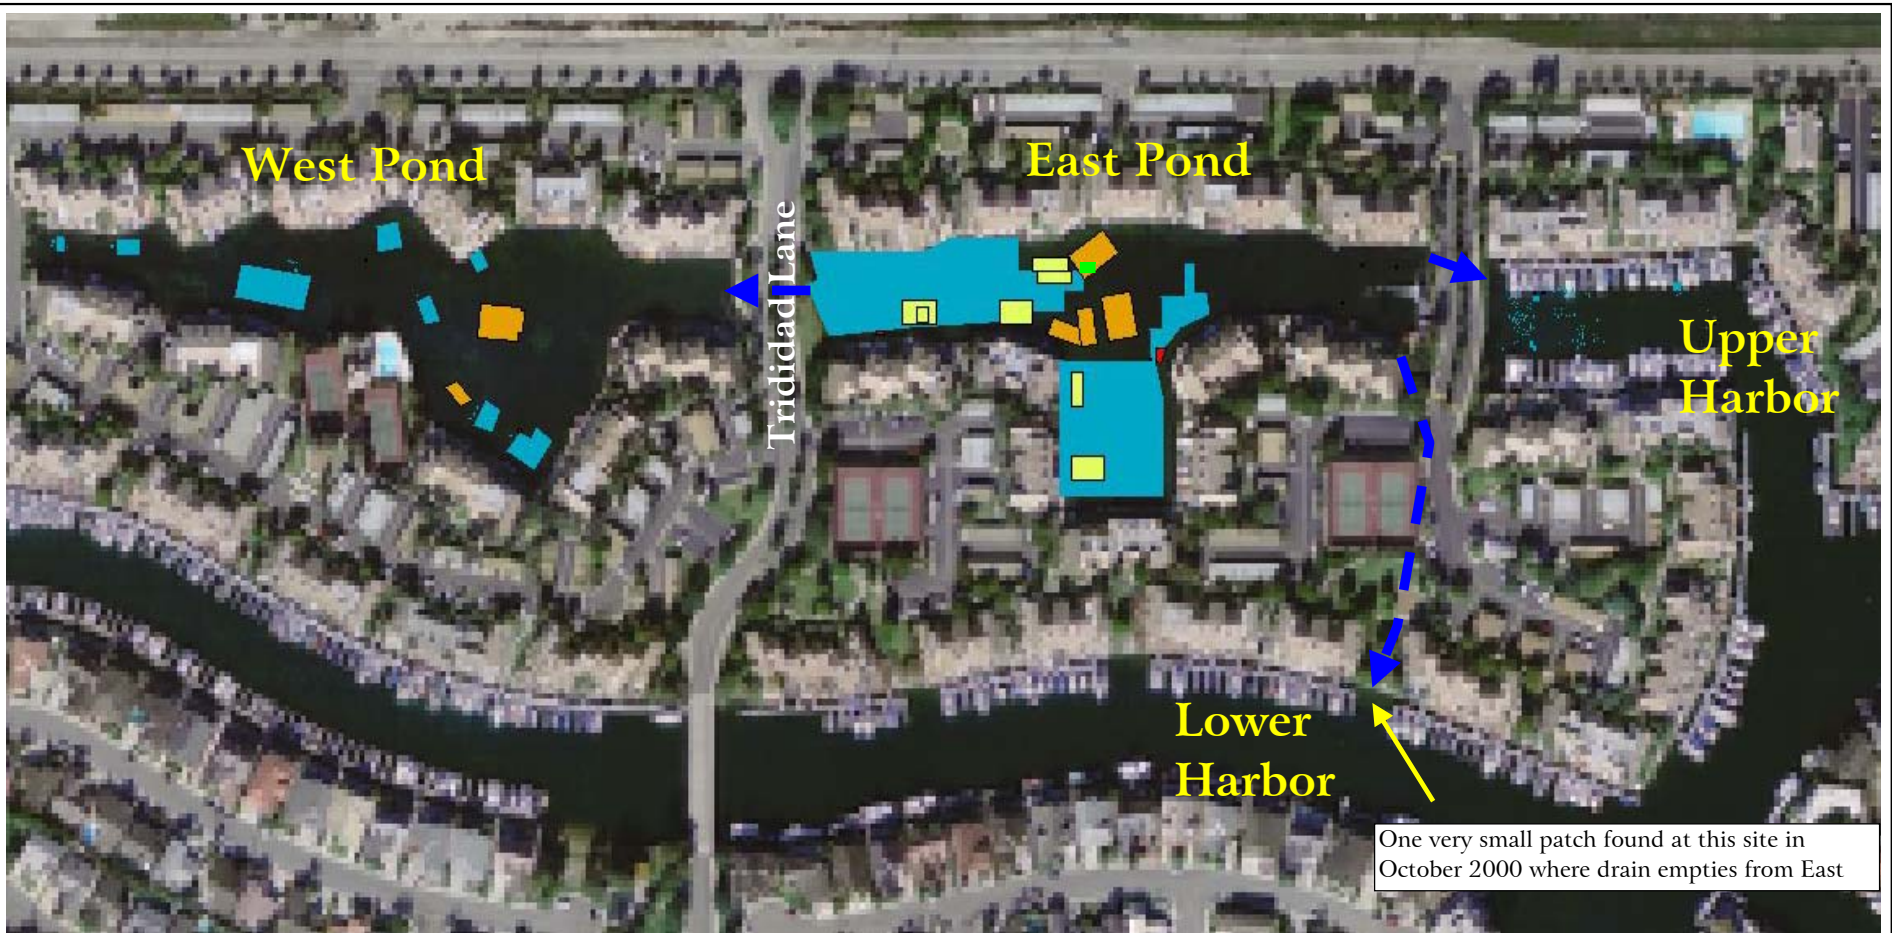
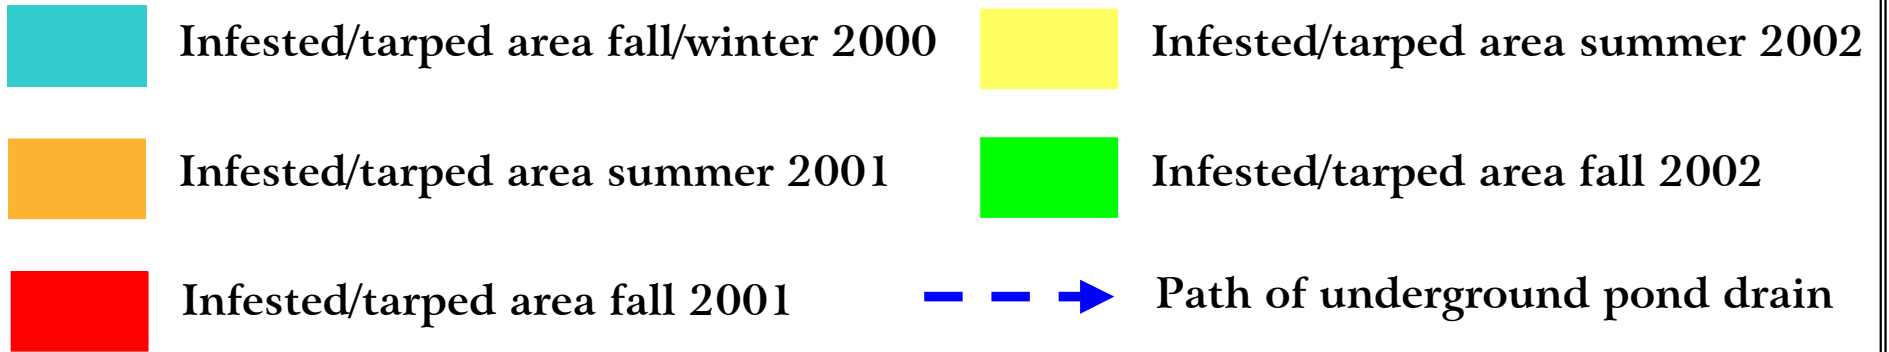
Figure
2

Locations of *Caulerpa taxifolia* infestation and treatment in Huntington Harbour
Huntington Beach, CA

As the water temperature rose in spring and summer 2001 following the initial treatment, additional patches of *C. taxifolia* emerged from the sediment in the east pond and additional tarps were placed to treat them (Figure 2). Follow-up surveys were repeated regularly to search for additional patches that may have arisen or grown to a larger, more detectable size. Observations by the survey team suggested that the burrowing and bolting behavior of the large population of round stingrays and gobies that occupied the east pond may have facilitated the spread of small fragments of *C. taxifolia*. Additionally, chronic high turbidity in the east pond severely limited visibility for the SCUBA survey team, increasing the possibility that small patches or fragments of *C. taxifolia* would go undetected until they grew to a larger size. As a result, surveys were conducted more frequently than quarterly during 2001 and 2002, with any detected occurrences quickly removed or tarped.

from the east to the west pond. Likely due to reduced turbidity (allowing increased light penetration) and to a lower abundance of benthic fish species, *C. taxifolia* in the west pond was distributed in more discrete patches. This made mapping and treatment less problematic than in the east pond. The infestation was detected in eight areas affecting approximately 1,094 m² of bottom within the west pond, which were tarped over a period extending from February to April 2001 (winter 2000)(Figure 2).

The follow-up monitoring program described above was initiated in the west pond spring 2001, using the same methodology. As anticipated, new occurrences were detected as the water temperature increased, and two additional areas in the west pond were tarped in August 2001 (Figure 2). Additional quarterly surveys found a small number of new occurrences over the next three quarters, generally associated with the edge of an existing tarp and likely the result of a fragment or buried plant material that had not been contained under the original tarp. These occurrences were treated with additional small tarps and chlorine.

A much larger area of infestation was also discovered in October 2000 at the upper harbor site, which is much deeper than the ponds (up to -17 ft MLLW) (Figure 1). The infestation was sparsely distributed, growing as small plants, with few fragments noted. Treatment of the detected *C. taxifolia* began immediately, with the placement of treatment tarps and smaller treatment tubs and chlorine over an affected area of approximately 93m². The initial treatment was completed by November 2000 (Figure 2).

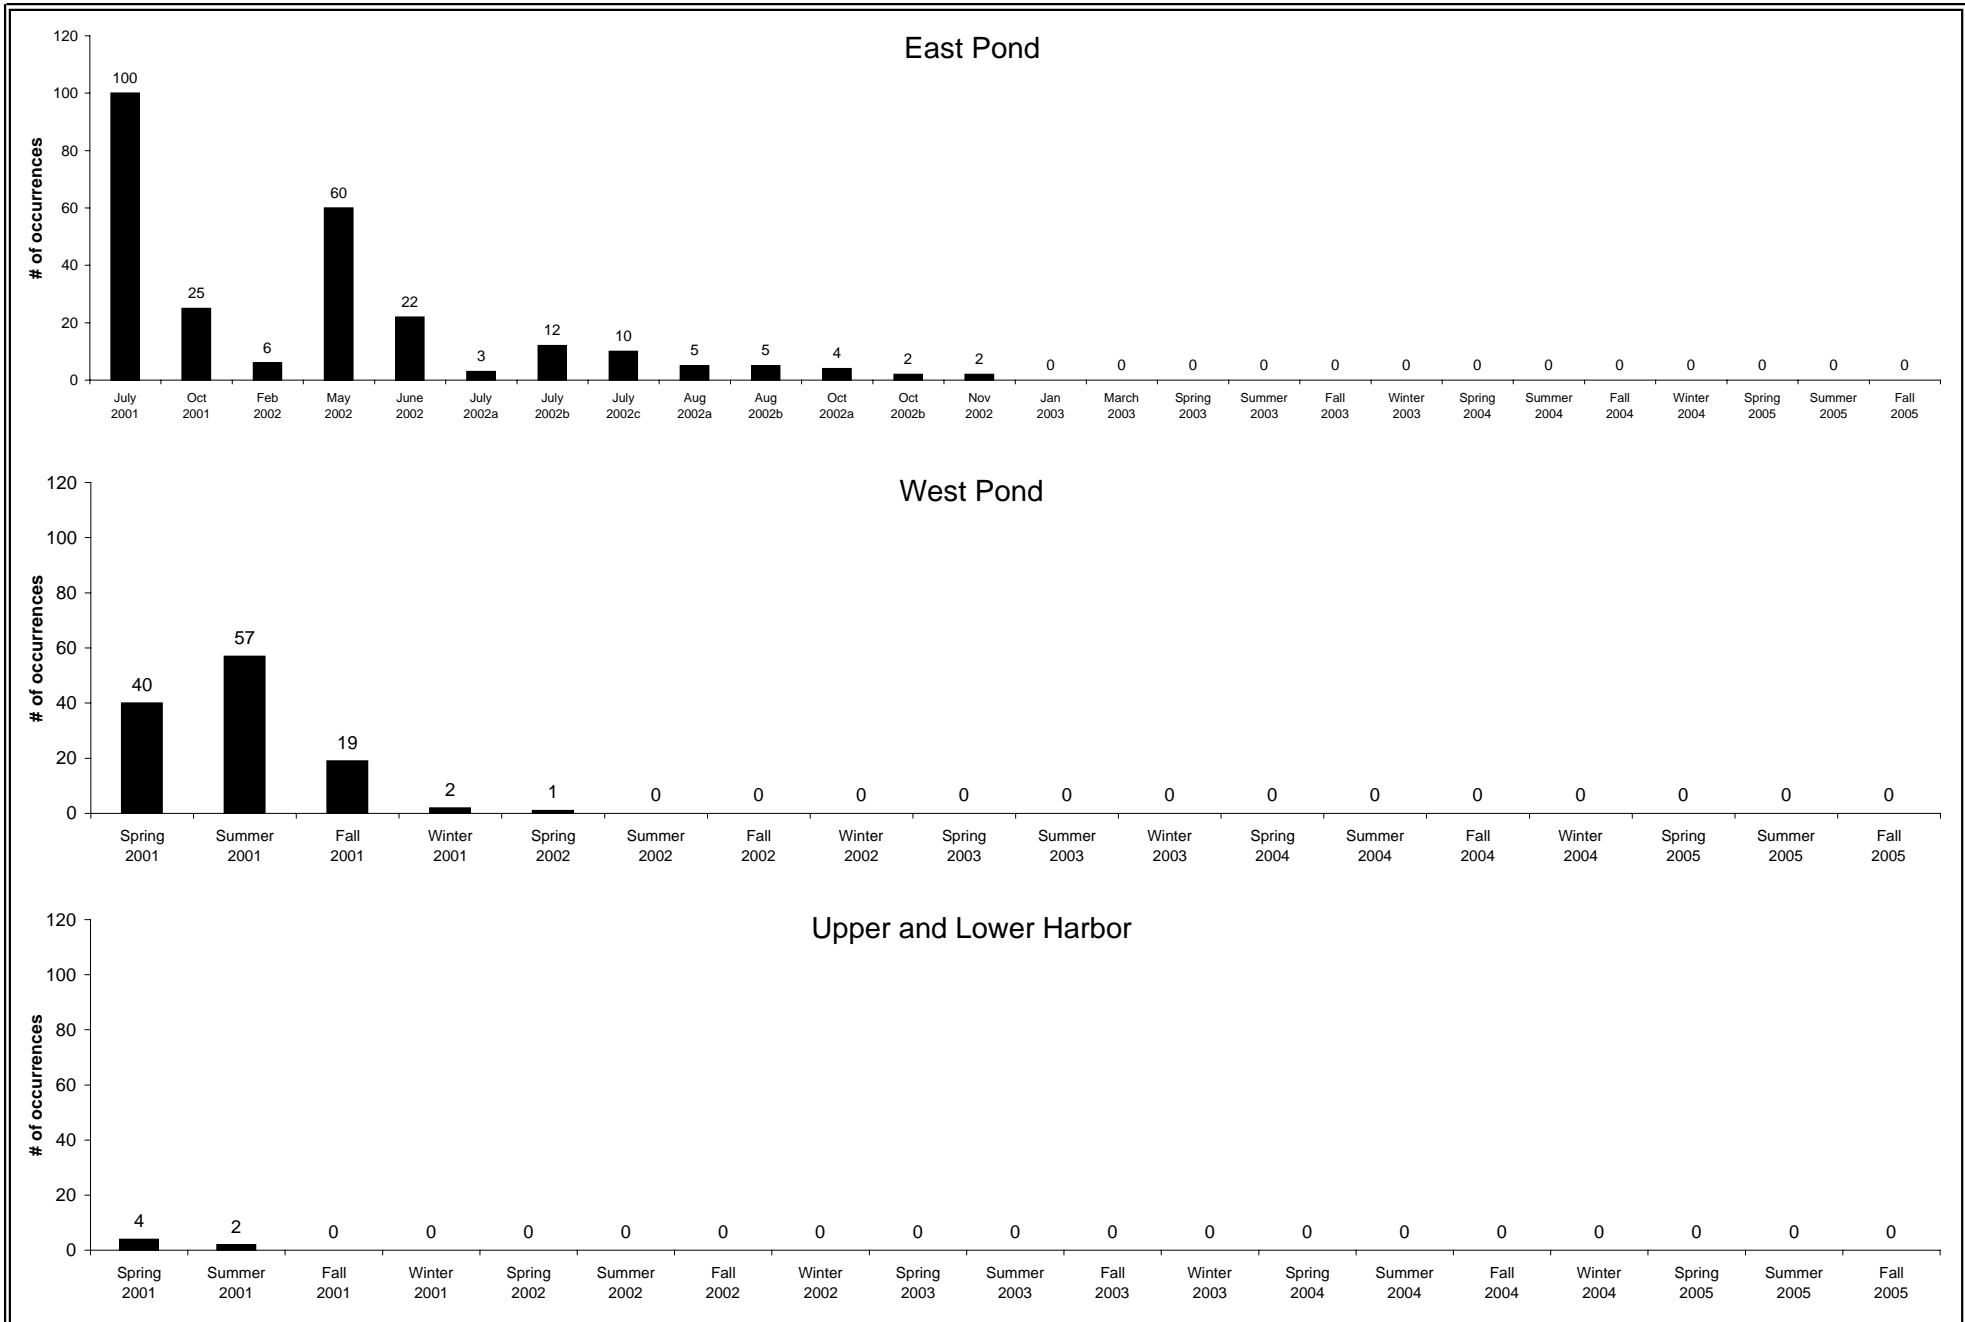
**Figure
3**

The progress of the eradication effort was tracked by the number of new plants or fragments detected during a given survey. Figure 3 presents the number of occurrences found during each survey. By fall 2002, intensive surveys were finding only a few small plants remaining, with the last occurrence detected on November 19, 2002. Follow-up surveys continued over the next three years. There have been thirteen additional surveys of the east pond since that time, with no *C. taxifolia* detected. The final survey (fall 2005) was conducted in December 2005.

**Number of new occurrences of *Caulerpa taxifolia* detected in follow-up surveys
 Infestation Areas: East Pond, West Pond, Upper and Lower Harbor
 2001-2005**

The last occurrence of *C. taxifolia* was detected in the west pond in May 2002 (Figure 3). Quarterly surveys continued over the next three years. Thirteen additional consecutive quarterly surveys of the west pond have failed to detect any persisting or new *C. taxifolia*. The final survey (fall 2005) was conducted in December 2005.

Follow-up surveys of the infested upper and lower harbor sites were initiated in spring 2001. *Caulerpa taxifolia* was never again detected at the lower harbor site (Figure 3). Additional
