Eradication and Surveillance of *Caulerpa taxifolia* within Huntington Harbour, Huntington Beach, California Status Report

May 2006

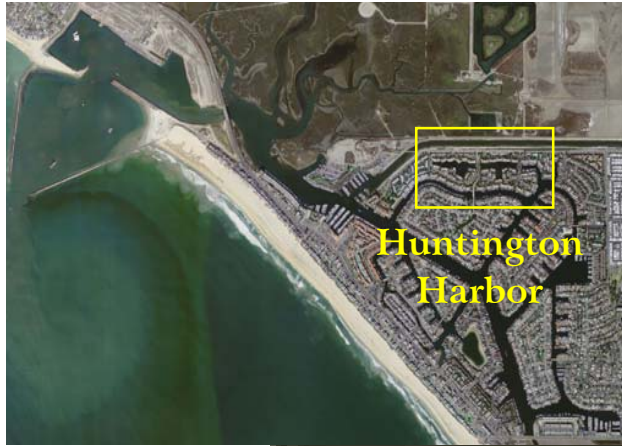
Figure
1

□ Areas infested by *Caulerpa taxifolia*

Caulerpa taxifolia infestation areas in Huntington Harbour - 2000
Huntington Beach, CA

In addition, *C. taxifolia* was discovered growing at two locations where outflow pipes drain the east pond back into the harbor. These sites are referred to as the north and south harbor sites (Figure 1). These areas reach a maximum depth of approximately -17 ft Mean Lower Low Water (MLLW).

The lower harbor infestation site is located immediately at the outflow of an underground drain that conveys skimmed water from the east pond to the lower harbor site (Figure 1). A small patch of *C. taxifolia* (~0.1m²) was discovered in October 2000, growing approximately 2 meters from the drain outlet, at a depth of approximately -6 ft MLLW. A single treatment tarp and chlorine was immediately placed over the patch.

A much larger area of infestation was also discovered in October 2000 at the upper harbor site, which is much deeper than the ponds (up to -17 ft MLLW) (Figure 1). The infestation was sparsely distributed, growing as small plants, with few fragments noted. Treatment of the detected *C. taxifolia* began immediately, with the placement of treatment tarps and smaller treatment tubs and chlorine over an affected area of approximately 93m². The initial treatment was completed by November 2000 (Figure 2).
